UT to Dixon Branch

Site 16

Photo Point #3 (Upstream)
Year 1 Summer - September 2009

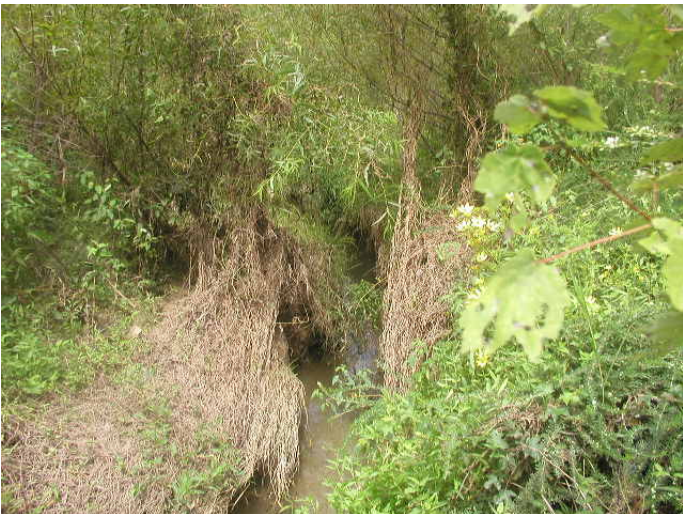
Photo Point #2 (Upstream)

UT to Dixon Branch (Site 16) stream relocation is experiencing some instability for the Year 1 Summer evaluation. A headcut noted during the last evaluation at Sta. 13+30 Ramp 2D which was downstream of Photo Point #2 has moved upstream of Photo Point #2 to Sta. 13+50 Ramp 2D. There is still some bank erosion on the left and right banks due to the head cut that has formed upstream. This bank erosion is at Sta. 13+20 Ramp 2D (Photo Point #3 Up and Downstream Photos). A bankfull event had occurred since the last monitoring evaluation. NCDOT is in the process of repairing the stream bed and banks at this time and will continue to monitor this stream relocation.

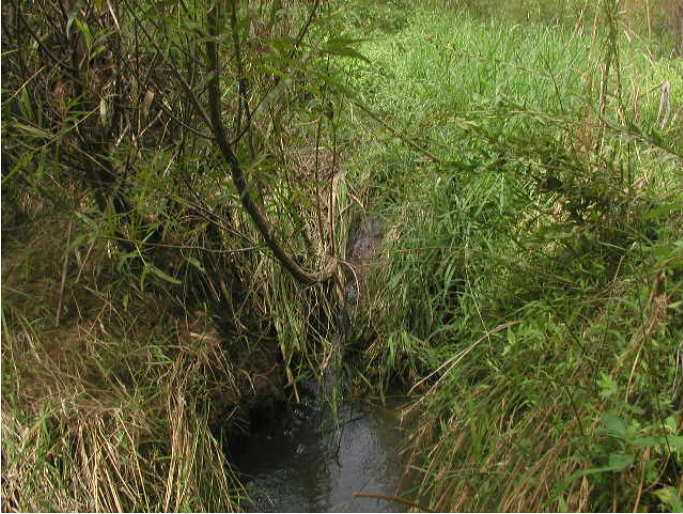
(Additional Photo of headcut upstream of
Photo Point #2)
